**LTPP Seasonal Monitoring
Program**

Site Monitoring Suspension
Status Report
Section 091803
Groton, Connecticut

CONNECTICUT SECTION 091803

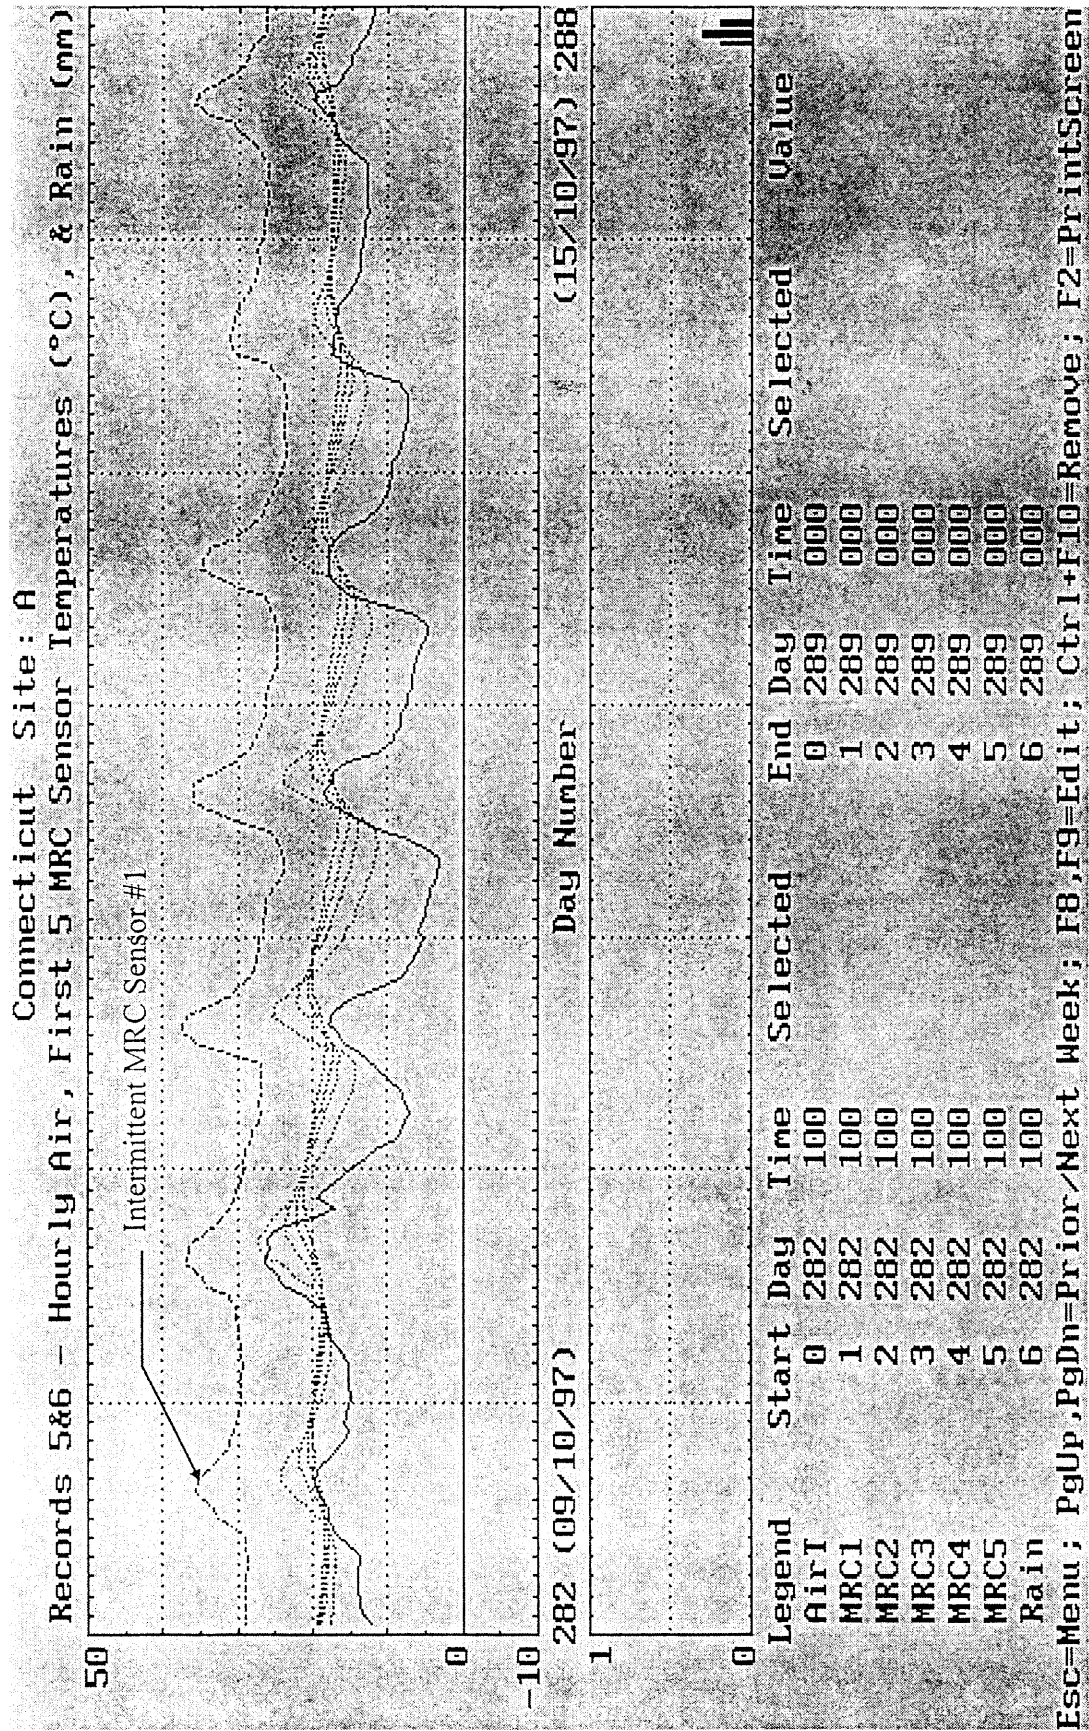
Figure 2: Sample of Erroneous Readings from MRC Sensor #1

At the time of suspension, MRC #1 sensor was not functioning. This sensor was not functioning at the time Round 2 data collection began in October 1996. Figure 1 shows a sample period during which MRC sensor #1 was malfunctioning. Other than MRC #1 sensor, there were no unresolved problems with any of the sensors at the time of suspension activities. The plots from ONSFIELD, MOBFIELD and SMPCHECK follow expected trends and produce expected values.

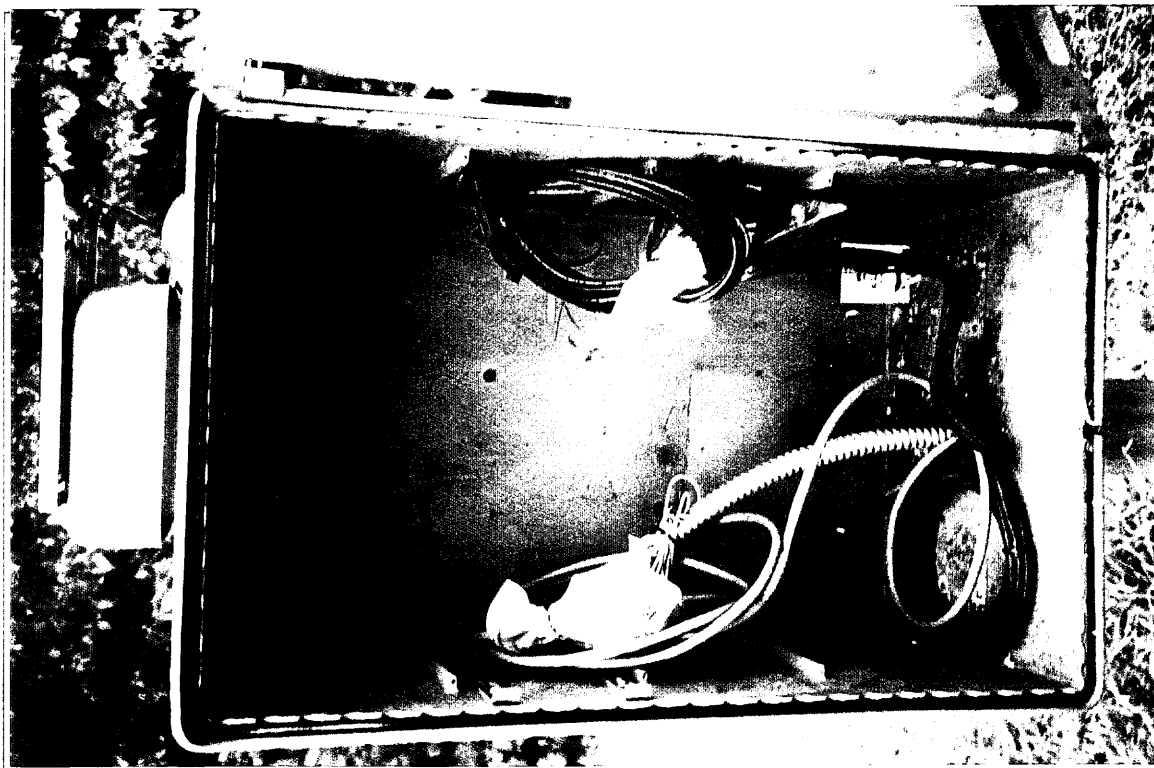
Inside Equipment Cabinet, Seasonal Site 091803 - Oct. 1997, after Suspension Activities

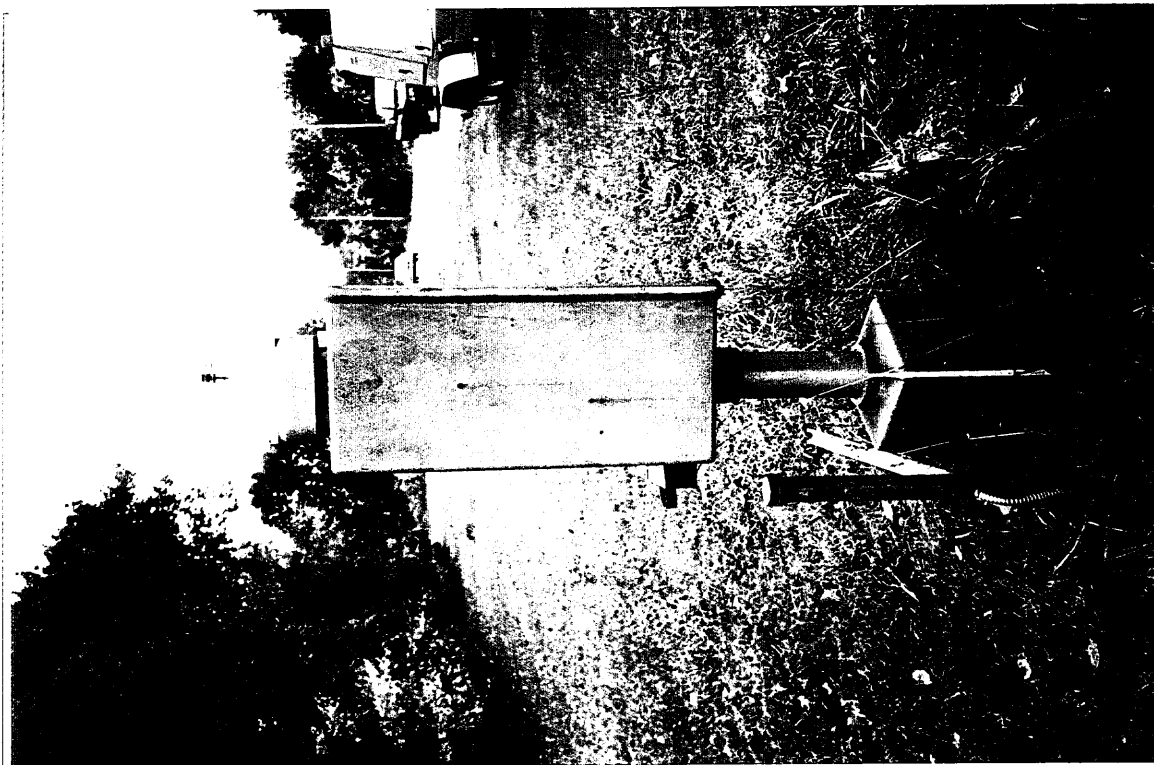
Equipment Cabinet, Lower portion of inst. pole, Seasonal Site 091803 - Oct. 1997, after Suspension Activities
